LOSS OF THE STEAMSHIP "TITANIC"

OF A FORMAL INVESTIGATION INTO THE
CIRCUMSTANCES ATTENDING THE FOUND-
ERING ON APRIL 15, 1912, OF THE BRITISH
STEAMSHIP "TITANIC," OF LIVERPOOL,
AFTER STRIKING ICE IN OR NEAR LATI-
TITUDE 41° 46' N., LONGITUDE 50° 14' W.,
NORTH ATLANTIC OCEAN, AS CONDUCTED
BY THE BRITISH GOVERNMENT

REPORT ON THE LOSS OF THE STEAMSHIP "TITANIC."

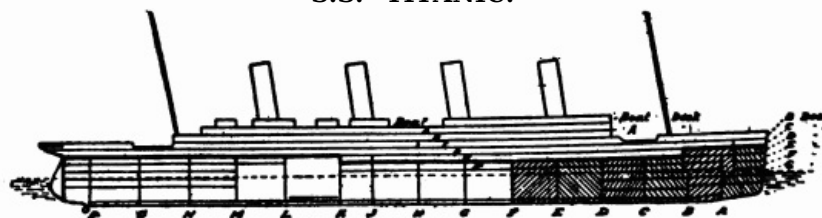
S.S. "TITANIC."

The collision with the iceberg, which took place at 11.40 p. m., caused damage to the bottom of the starboard side of the vessel at about 10 feet above the level of the keel, but there was no damage above this height. There was damage in—

The damage extended over a length of about 300 feet.

It will thus be seen that all the six compartments forward of No. 4 boiler room were open to the sea by damage which existed at about 10 feet above the keel. At 10 minutes after the collision the water seems to have risen to about 14 feet above the keel in all these compartments except No. 5 boiler room. After the first ten minutes the water rose steadily in all these six compartments. The forepeak above the peak tank was not filled until an hour after

NOTE.—The vertical letters signify the different decks. The horizontal letters signify the water-tight bulkheads. The heavy line shows the top of the water-tight bulkheads. The crosshatched compartments are those opened to the sea at the time of the collision with the iceberg.
