Title: Records of Steam Boiler Explosions

Author: Edward Bindon Marten

MEM. INST. OF MECHANICAL ENGINEERS; ASSOCIATE OF INSTITUTION OF CIVIL ENGINEERS, AND CHIEF
ENGINEER TO THE MIDLAND STEAM BOILER INSPECTION AND ASSURANCE CO.

1872.

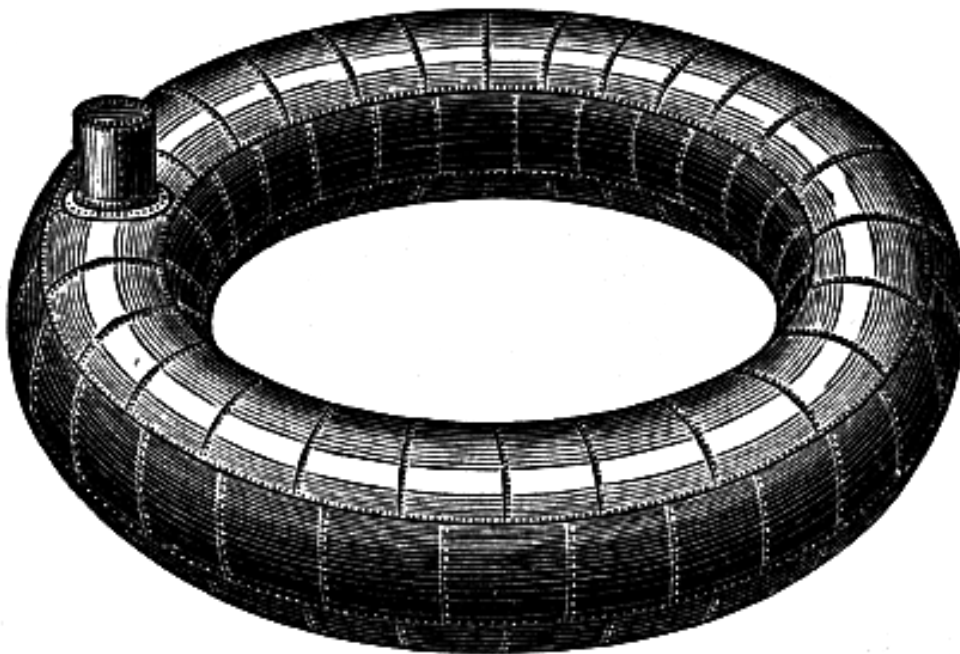
Fig. 26.

One boiler has been seen by the writer where extreme length was avoided by curling the boiler round until the ends met forming a Ring or Annular boiler. This boiler is shown in [Fig. 26](#), and is 5 feet diameter with 25 feet external diameter of the ring, or a mean length of about 63 feet; it has been found to work well for some years, although exposed to the heat of six puddling furnaces.

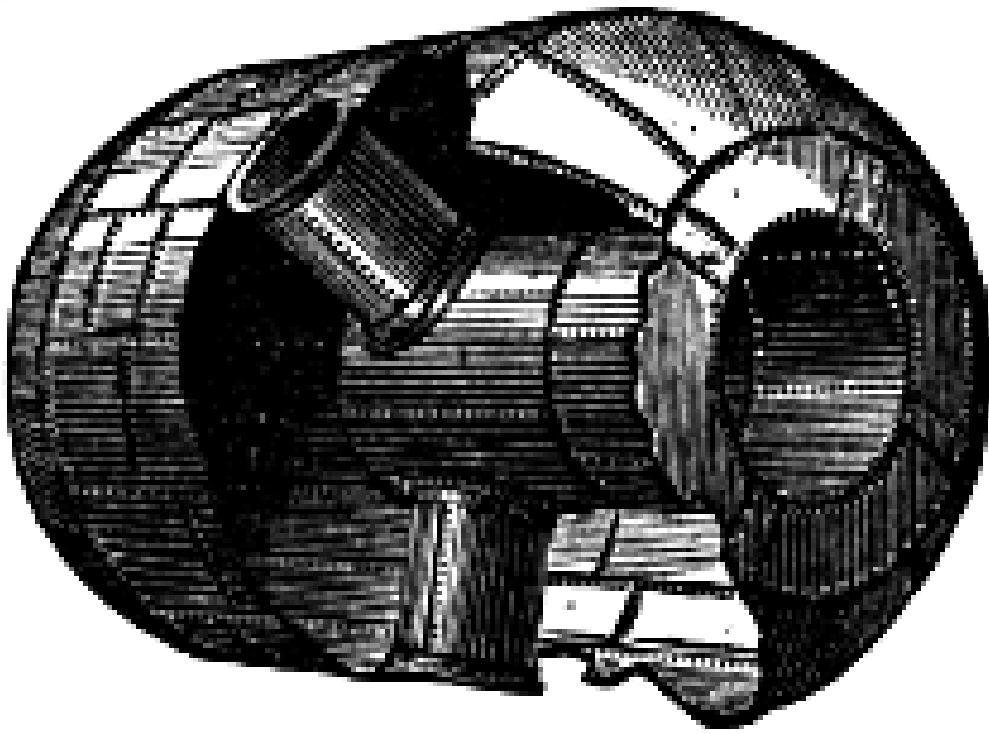
Fig. 28.

In the explosion shown in [Fig. 28](#), and in the model exhibited, which occurred at Westbromwich in 1864, the lower part of the side of an upright boiler was blown out; and the liberated part was also divided into two pieces, each of which fell some distance behind the boiler, in an opposite direction to the side from which they came. The explanation of this became obvious on examination, as the cause of the rupture had been the corrosion of the bottom, and the rent had run up the seams until it met the angle iron of the side tubes, round which it ran to the first seam above. This seam acted as a hinge on which the ruptured pieces turned, and they swung round so violently that they were wrenched off, but not before they had pulled the boiler over and received the diverting force which gave them their direction, for they flew off at a tangent, to the circle in which they had swung round on the sound upper seam as upon a hinge.

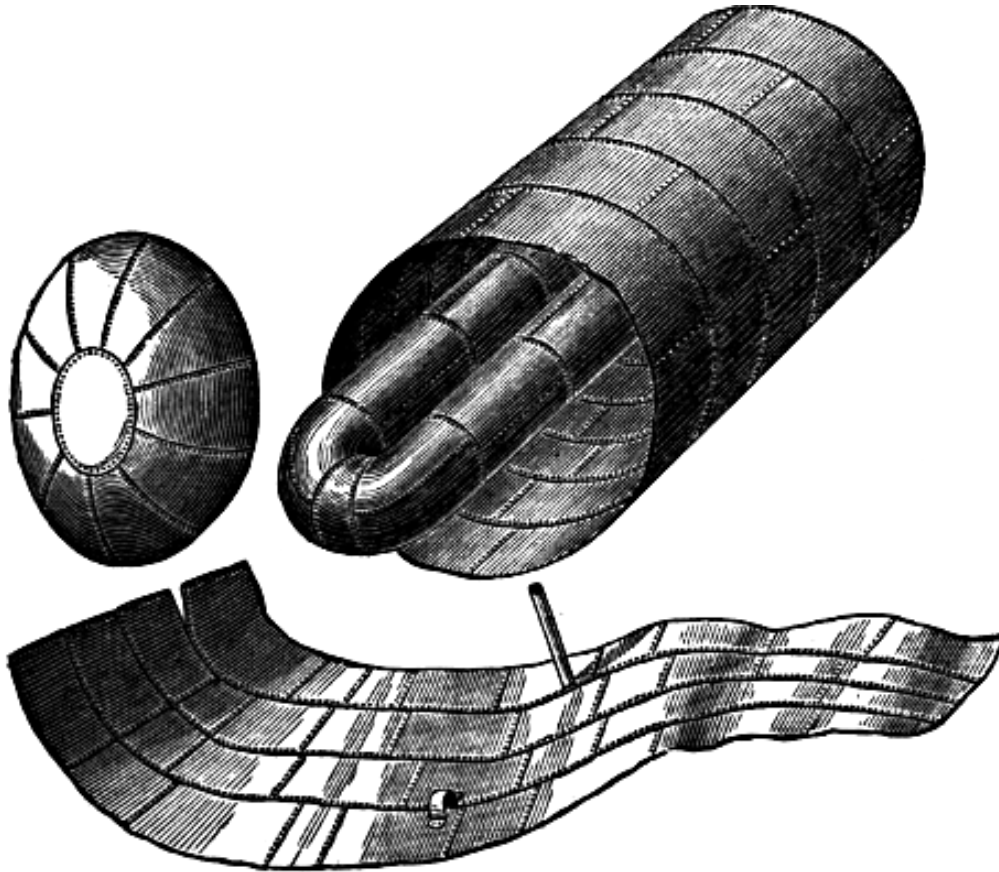
Fig. 36.

Explosions of these boilers have sometimes taken place by collapse of the tubes, but much more generally by the failure of the shell over the fire, as shown in the sketch [Fig. 36](#), representing an explosion that occurred at Wolverhampton in 1865, in which the first rent took place in a seam over the fire where frequent repair had led to a considerable length of longitudinal seam being in one continuous line. The four plates over the fire parted and opened out until they had ripped two seams completely round the boiler; and the plates were thrown in one flat piece, as shown, upon a bank behind. The main body of the boiler with the tubes was turned over, and the front end blown away.

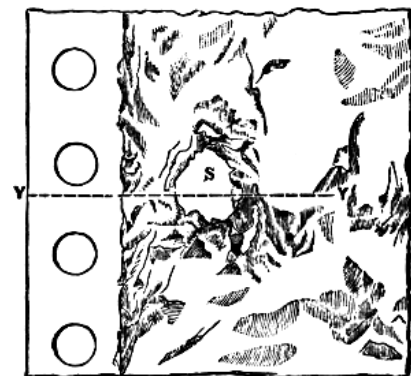
Fig. 62.

Similar mischief has been noticed in boilers covered with sand, as shown in the sketches [Fig. 62](#) and [Fig. 63](#), which represent an instance of corrosion after eight years' working; although nothing forms a better covering than sand for preventing loss of heat by radiation. In both these examples it will be seen that the corrosion has continued until the thickness of the plate has been so eaten away that a hole has been burst out at **SS**. A very good covering is formed by brickwork in cement; or various cements made for the purpose, which adhere to the surface of the plate and yet show leakage; or such materials as sacking or felt; or sheet-iron casing, leaving about 6 inches of air space all round the boiler. But all these have the great objection that they hide the boiler from inspection, except by the expensive process of removing the covering; and in this way dangers that have caused explosion have remained hidden from observation.

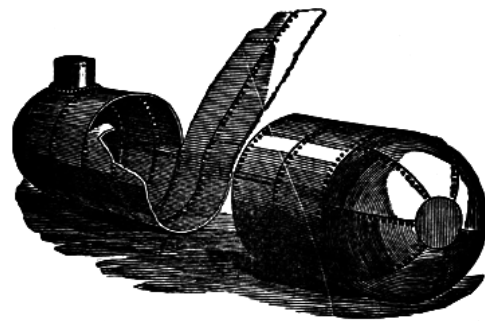
Fig. 6.

No.9. Birmingham. (Fig. 6.)

Plain Cylindrical Boiler, with hemispherical ends, 23ft. long, and 5ft. diameter, $\frac{3}{8}$ inch plates, 50 lbs. It was set so as to be fired under the bottom if required, but the grate was seldom used. The principal heat was supplied from a mill furnace, the neck of which was at the left hand of the back, and the flame was carried by a wheel flue round the front of the boiler to the stack on the right hand side of the back. The boiler was fitted with a $4\frac{3}{4}$ -inch safety valve, and also a float, but it was suspected that the latter had broken from the rod.

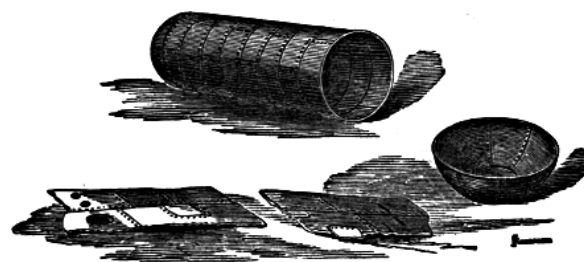
Fig. 10.

A longitudinal seam gave way over the fire, when two rings of plates opened out, rending the transverse seams at each side until completely separated, and fell in two parts at a distance of about 100 yards in front of the boiler. The front end was liberated and fell in one piece about 100 yards beyond the two pieces of the shell. The main body of the boiler was driven back a few yards and rolled over so as to be upside down, but was little injured.

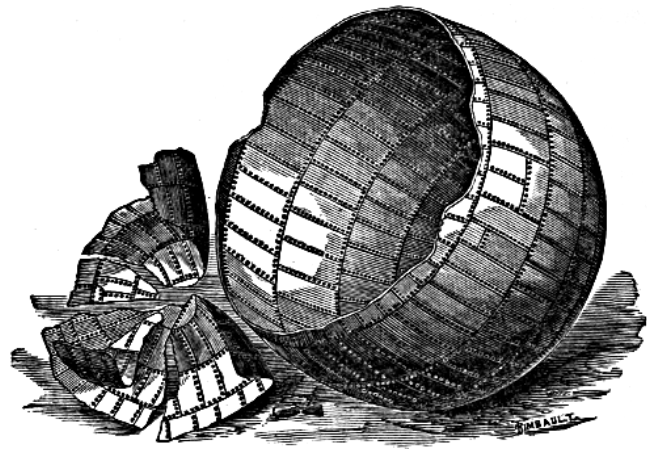
Fig. 15.

Balloon, 22ft. diameter, pressure 5 lbs. Bottom blew out and was torn in pieces. Main portion of shell fell over on to another boiler. The cause of explosion was deep corrosion along the bottom where it rested on the brickwork.

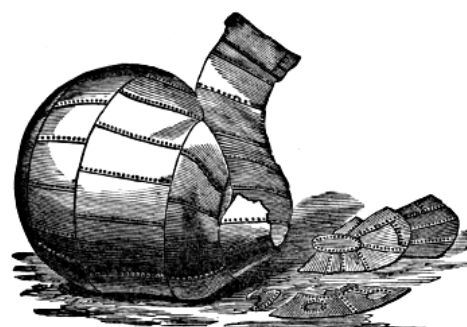
Fig. 30.

Balloon, 11ft. 6in. diameter, and 11ft. 6in. high, plates 3/8 inch. Bottom domed up 3ft. 6in. over fire; ordinary pressure 8 lbs. Boiler had worked two days at 25 lbs. pressure, but safety valve loaded to 16 lbs. The cause of explosion was undue pressure for an old boiler of such weak shape.

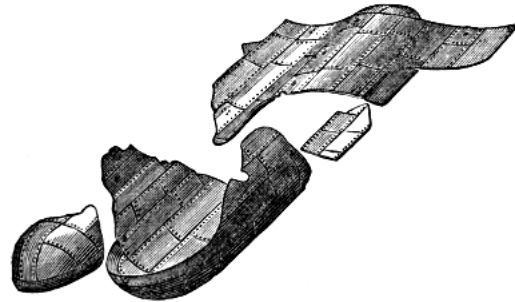
Fig. 1.

One of three. Plain Cylinder, 27ft. long, 5ft. diameter, $\frac{3}{8}$ inch plates, 35 lbs. pressure. The boiler was much torn up, and all the fragments thrown to the front of their original position. The cause of the explosion was that the boiler was very old and much deteriorated, so that it was unable to bear the ordinary pressure. The longitudinal arrangement of the plates, and the entrance of the feed directly on the bottom, no doubt contributed to the weakness.

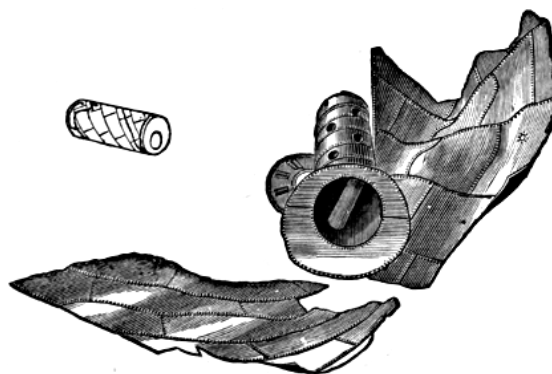
Fig. 13.

One tube Cornish, 24ft. long, 6ft. diameter. Tube 3ft. 3in. diameter, 3/8 inch plates, 40 lbs. pressure. The seams were arranged diagonally, but the rents had not followed the seams, but had torn the plates. The shell gave way where extensive corrosion had reduced the plates to 1/8 inch in thickness, and all the shell was blown off, and the tube thrown over and turned end for end.

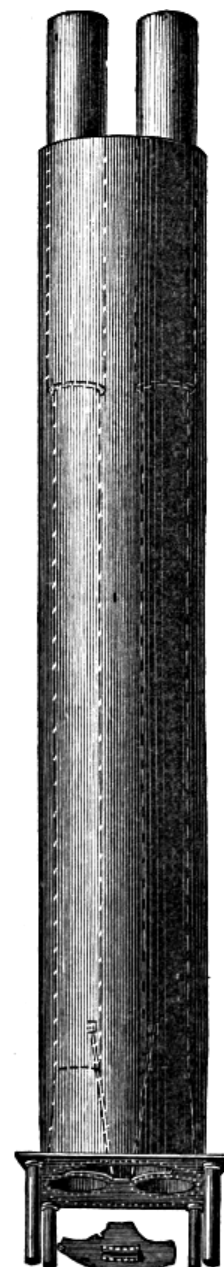
Fig. 17.

Two Furnace Chimney Boiler, 42ft. 4in. high, 6ft. 9in. diameter, 1/2 inch plates, 50 lbs. pressure. Nearly half the bottom plate was blown out, and the issuing contents found their way into the furnace and increased the damage. The line of rupture near where it joined the shell was corroded almost to a knife edge, which so reduced its strength as to make it unable to bear the usual working pressure of steam, in addition to that of the column of water in the boiler.

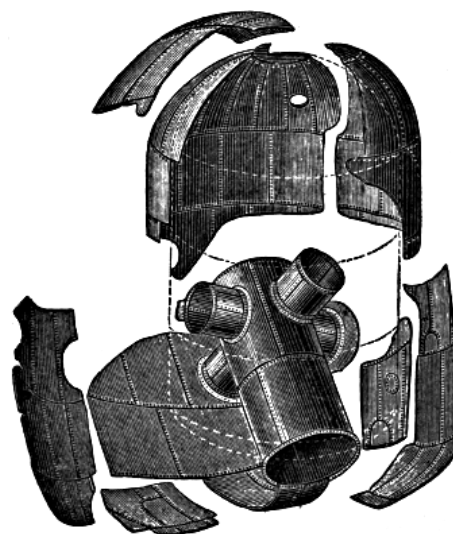
Fig. 19.

One of four. Four Furnace Upright, 22ft. high, 10ft. 6in. diameter, $\frac{7}{16}$ inch plates, 40 lbs. pressure. The boiler was rent into nine pieces, one of which was not found. The dotted line in sketch shows the outline of the boiler before explosion, and the fragments are arranged as nearly as possible in their original position. The first rent was at a seam-rip opposite the largest furnace, from whence the rupture opened in every direction. This seam-rip must have existed some time before explosion, and must have extended from rivet to rivet, until the boiler was so much weakened as to be unable to bear the usual pressure.

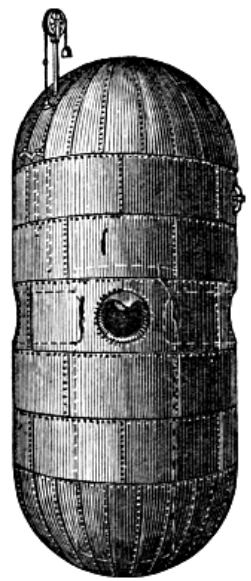
Fig. 26.

One of eight. Four Furnace Upright, 22ft. high, 9ft. diameter, 7/16 inch plates, 45 lbs. pressure. The water was allowed to get so low that the shell was overheated and rent, and the side tube slightly collapsed, and the injury was not discovered until the feed water had risen up to the rupture, when it ran into the furnaces without causing any violent explosion, although cold water had been put into a red hot boiler.

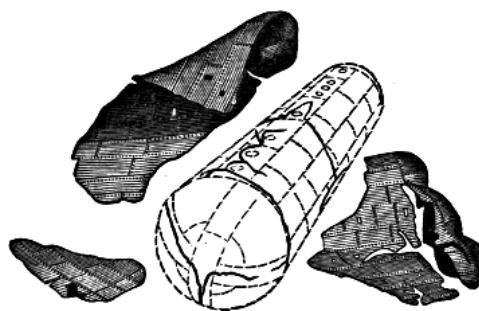
Fig. 5.

One of twelve. Plain cylinder, 13 years old, 30ft. long, 6ft. diameter, $\frac{3}{8}$ inch plates, 35 lbs. pressure. The plates were arranged lengthways, so that the seams were in continuous lines from end to end. This has often been mentioned as giving far less strength than where the plates are placed in rings. There had been considerable repair at various times, and just previous to explosion the boiler had been placed as was supposed in thorough repair, and some new plates had been put over the fireplace. The first rent appears to have taken place where one of these plates joined the old work. The rent quickly extended along a straight seam, and the boiler was blown into three pieces. The explosion was simply caused by the boiler having been weakened by frequent repair until unable to bear the ordinary working pressure. Externally fired boilers, when so frequently patched become treacherous and uncertain, and more especially so when the seams run from end to end. See [No. 59.](#)

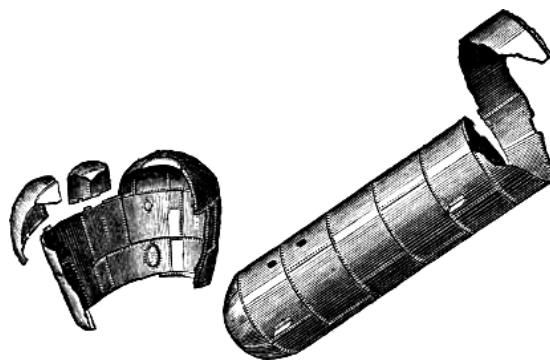
Fig. 8.

One of two. Plain cylinder, 25ft. long, 4ft. 6in. diameter, 3/8 inch plates, 42 lbs. pressure. The boiler had been very frequently repaired, and a seam gave way where a large patch had just previously been put on over the fire, in doing which the rivet holes of the old work had evidently been cracked, rendering the boiler unable to bear the usual working pressure. See [No. 45](#).

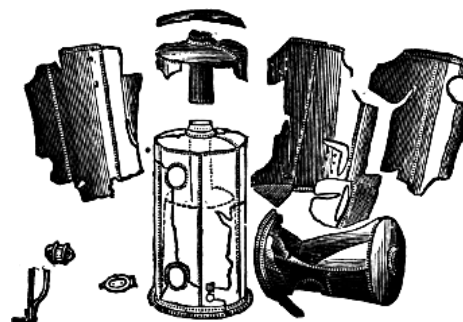
Fig. 10.

Portable Crane, 8 years old, 8ft. 3in. high, 4ft. 4in. diameter, with internal fire box, 6ft. high and 3ft. 6in. diameter, and chimney passing out at the top, 5/16 inch plates, 40 lbs. pressure. The internal fire box crushed in sideways, and the shell was rent into several pieces. The attachment of the fire box to the shell was made by bending the plates, as shown in enlarged sketch, and this is not so rigid as double angle iron and had evidently strained the chimney tube. This weakness had been so increased by deep corrosion just at the bend of the plates that it had given way. The havoc and loss of life was far greater than would have been supposed possible from so small a boiler, but similar cases are mentioned in [No. 43](#), 1868, and [No. 57](#), 1866.

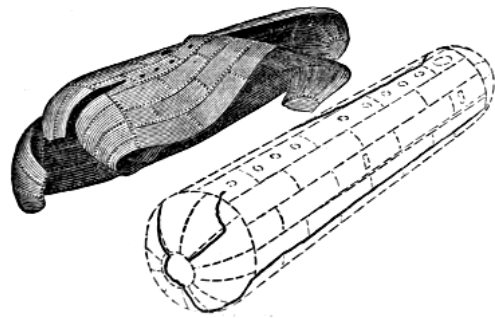
Fig. 11.

One of two. Plain cylinder, with plates arranged lengthways, 30ft. long, 6ft. diameter, 3/8 inch plates, 9 lbs. pressure. A seam gave way on the right side over the fire and immediately rent along the straight seam from end to end, and the boiler was thrown in one mass a great distance to the left. The boiler was very old and much weakened by frequent repair, and at the time of explosion was being imprudently worked at twice its usual pressure for a temporary purpose. See [No. 59](#).

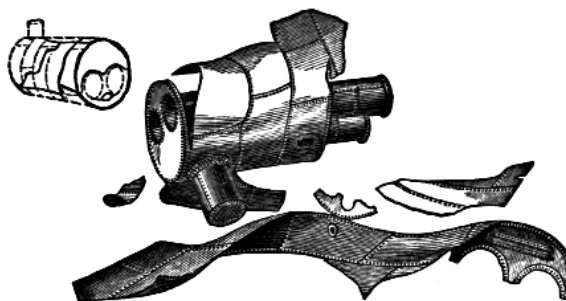
Fig. 17.

Two tube Cornish, 16ft. long, 6ft. 9in. diameter, 7/16 inch plates, 50 lbs. pressure. Tubes 2ft. 6in. diameter. The bottom was so much corroded that it rent open, and the boiler was torn to pieces which were scattered to wide distances. The boiler had been much neglected and badly used, and the safety valve was insufficient, of bad construction, and overloaded, and the alarm whistle was gagged.

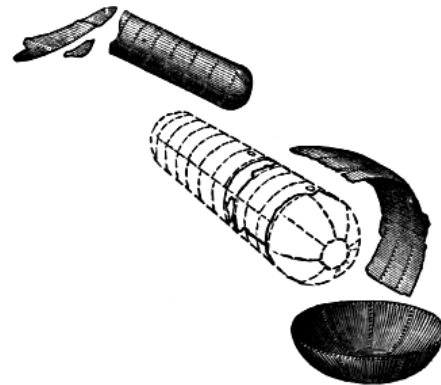
Fig. 19.

Plain Cylinder, 25ft. long, 4ft. 6in. diameter, $\frac{7}{16}$ inch plates, 25 lbs. pressure. The plates along the line of rupture were corroded to $\frac{1}{16}$ inch, and in some places much less, so that the boiler was quite unfit for the ordinary working pressure.
